Asian Journal of Science and Technology
Vol. 09, Issue, 08, pp.8467-8472, August, 2018

MECHANICAL PROPERTIES FOR SURKHI BONDED KATHMANDU WORLD HERITAGE BUILDINGS

*Hari Ram Parajuli

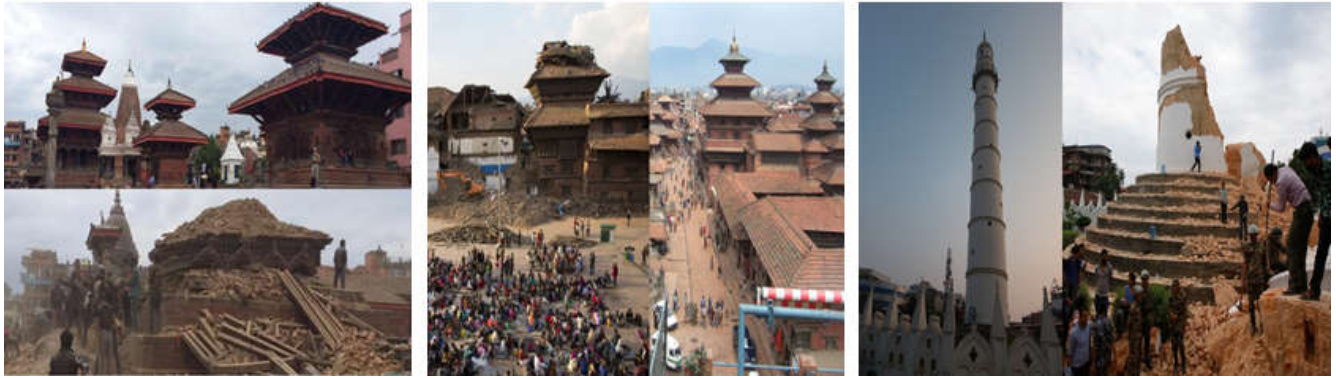
a. Hanumandhoka Durbar square

b. Patan Durbar Square

c. Dharahara (Bhimsen Stambha)

Figure 1. Damages in Heritage buildings before and after the 2015 Gorkha earthquake

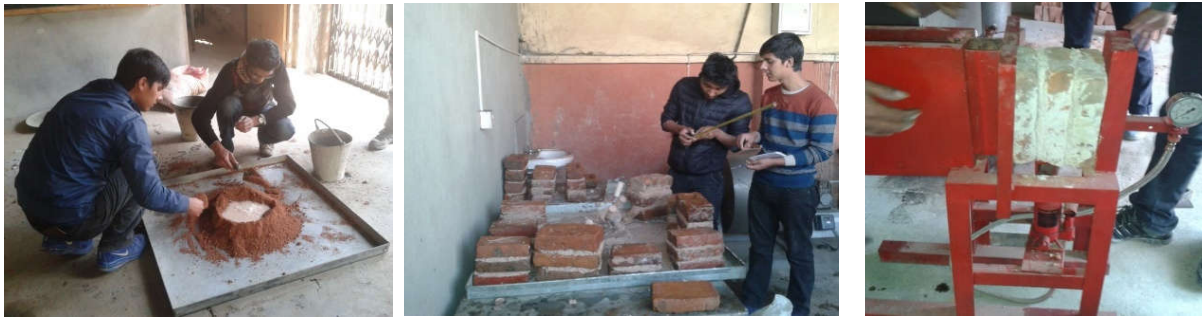
Figure 2. Preparation of Surkhi mortar

First, lime in powder form, fine Surkhi and dry sand is mixed thoroughly till the mix appeared uniform color. The water was then added as shown in Fig. 2 and shoveled or hoed thoroughly until the mortar was easily workable and the ingredients were thoroughly distributed. Fifty percent of total weight of lime was mixed in powdered dry form with other ingredients of mortar and the remaining was mixed with water and left for two days so as to allow for full reaction. The lime solution was then added to the dry mix to make mortar workable.

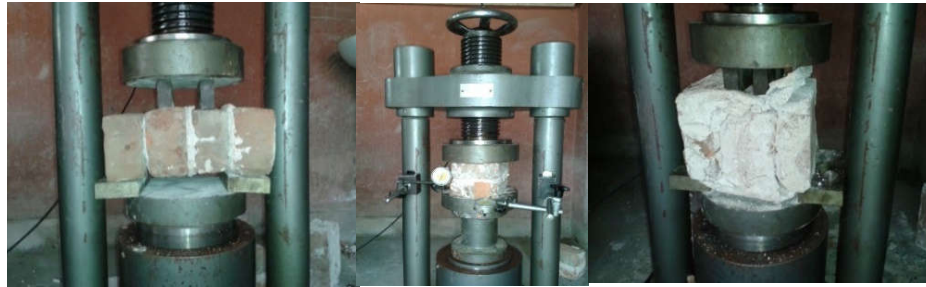
**Fig. 6. Compression testing****Table 4. Compression strength of mortar (1:1:3)**

Compressive strength test of reinforced and unreinforced masonry specimens consisting of two bricks with and without mortar were tested in compression testing machine (Fig 2). The least count of the machine was 7.5 kN. In order to obtain the mechanical properties of the brick and mortar, dial gauges were fitted in the vertical and lateral direction which measured the normal and lateral deformation of the specimen.
