ASIAN JOURNAL OF  
SCIENCE AND TECHNOLOGY

Asian Journal of Science and Technology  
Vol. 13, Issue, 10, pp.12199-12210, October, 2022

# AUSCULTATION TECHNIQUES FOR HERITAGE BUILDINGS

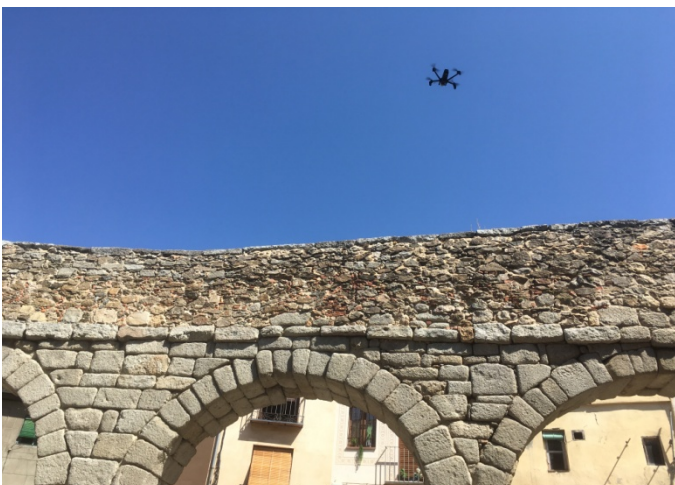
**Fig. 1. Quadrotor drone flying over the Roman Aqueduct of Segovia, for inspection (photo by the author)**

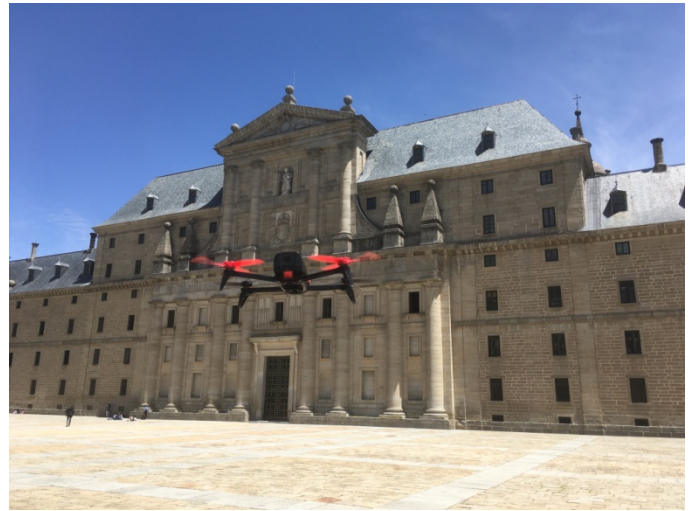
**Fig. 2. Quadrotor drone ready to take off, for an inspection on the main facade of the Monastery of El Escorial, Spain (photo by the author).**

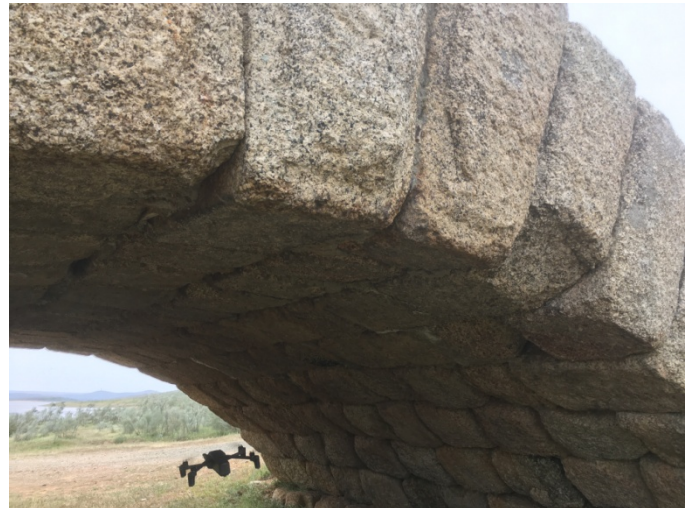
**Fig. 3. Quadcopter drone circulating inside the first vault of the Roman Bridge of Alconetar (Spain), for its intrados inspection (photo by the author)**

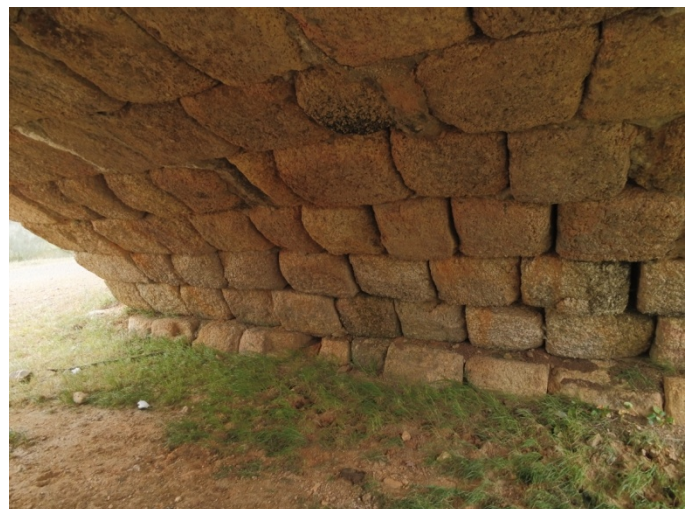
**Fig. 4. Image taken by the drone during its transit through the interior of the vault, captured in Fig. 3 (photo by the author)**

**General reconnaissance and visual inspection:** No instrumental technique can substitute for careful observation. Inspection by an experienced eye is key in any reconnaissance process. The examination of the materials that make up the monument (stone, brick, mortar,...). It is convenient to help us with a knife and a magnifying glass (or a pocket microscope). Later, we will observe the injuries and the processes that can affect the materials and the causes of these injuries (García de Miguel, 2009). Inspection is essential for recognition. Structural inspection is an essential operation for the conservation of any construction (Rojo, 2020). This was initially applied (and in a very specific way) to the structural field. This is independent of the constituent material of the structure (Hugenschmidt & Mastrangelo 2006; Sandberg *et al.* 2022). Inspection is also essential in any heritage construction for its preventive conservation (Tortajada Hernando, 2011). The inspection essentially consists of the characterization and monitoring of the construction, as well as each of the different elements that make it up (Bianchi & Hebdon 2022). This may be accompanied by tests, depending on the type and scope of inspection undertaken. Some of these essays will be analyzed here. All these tests must allow for complementing the diagnosis made by visual inspection. In recent years, drones have been incorporated to carry out this type of inspection (Elizalde, 2022, a). Several experimental inspections carried out on constructions have shown that the use of a suitable drone (Fig. 1, Fig. 2 y Fig. 3) allows a detailed and complete visual observation (Fig. 4) of all the visible elements of the

All of the above implies considerable economic savings, which does not imply a decrease in the quality of work. With the data collected with the drone (Fig. 4), a complete technical report of the inspection carried out can be generated in the cabinet, in addition to supplying the pertinent information for its incorporation into a management system and obtaining the status indices of each of the elements and the construction as a whole, to assess whether any type of urgent action is required or to verify, through a regular check of the injuries detected through periodic flights, the evolution of said injuries.

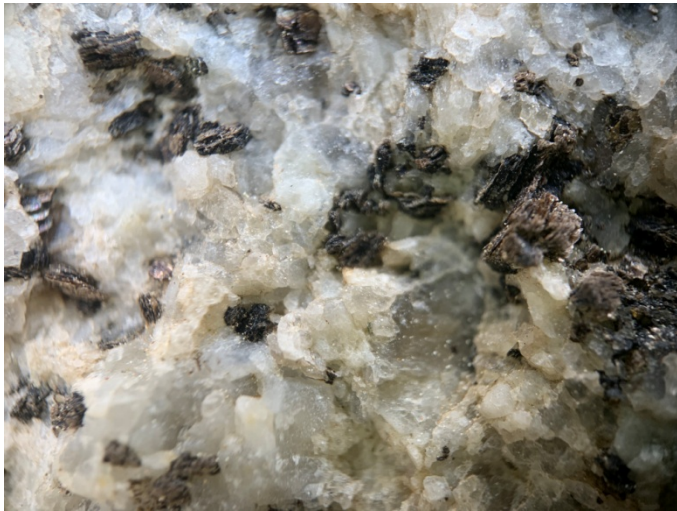
**Fig. 5. The texture of the granite of an ashlar from the Monastery of El Escorial (Spain), seen with a 50X magnifying glass(photo by the author)**

Granite is the sum of quartz, mica, and feldspar. Thus, calcosodic feldspar is always white and potassium feldspar can also be white or cream-colored (Fig. 5); however, the potassium feldspar in some granites is pink or red. In any case, all feldspars have a stone-like sheen. Morphologically, mica is laminar and shiny. It can be white or black (in Fig. 5 it is black). Its strong basal transept is characteristic. Sometimes several small sheets are grouped into one unit. Black mica may have a certain bronze sheen (Fig. 5). For its part, the quartz of the granite appears as grayish grains. Granite can have different particular textures. For example, it can present large white feldspar crystals, like "horse's teeth". In some varieties these crystals are sporadic, but in other varieties, they are very abundant. Sometimes they show up oriented. Black micas can also form dark aggregates. Other discontinuities in the granite present rounded dark spots called barges (García de Miguel, 2009). Sometimes we can see fragments of other rocks included in its mass, known as enclaves (García Moreno & CorretgéCastañón, 1999); or we can find bands of dark minerals, known as schlieren (Wiebe *et al.*, 2007). When the grains on its surface are altered, they come off with the touch of the hand (Alemany, 2007). Coarse sand appears in the vicinity, made of quartz and feldspar grains of irregular shapes and sizes (archoic sands). The limestones and dolomites are identical. Both are easily scratched by a razor (Fig. 7). Their colors and textures can vary widely. With a drop of hydrochloric acid, limestone produces strong effervescence, while dolomite is not affected. This serves as a diagnosis to distinguish them (Liu *et al.*, 2005). Normally the grain size cannot be distinguished with the naked eye. Sometimes they

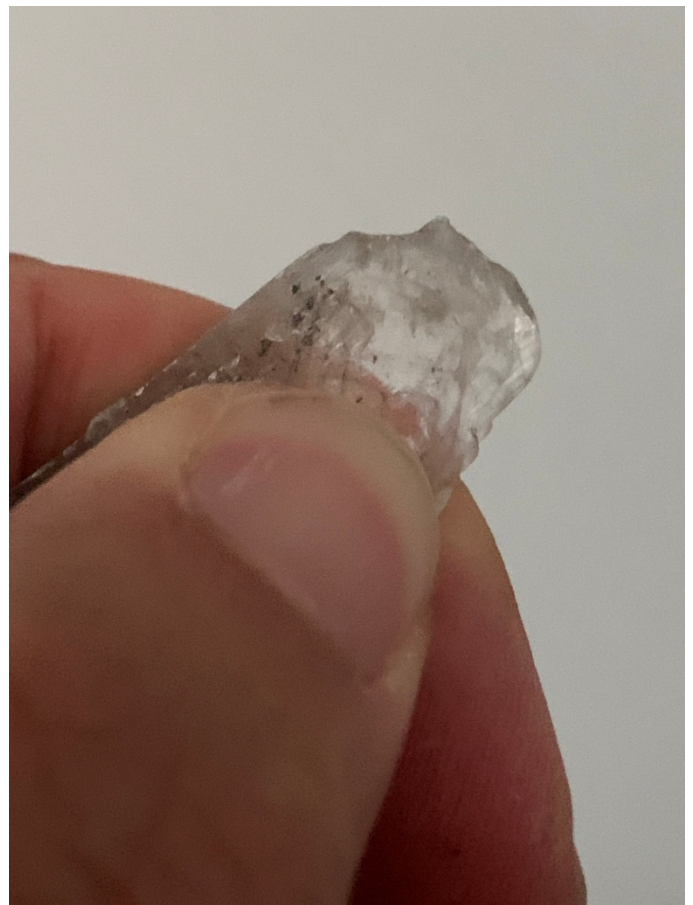
**Fig. 6. Crystallized gypsum, which can be scratched with a fingernail (photo by the author).**

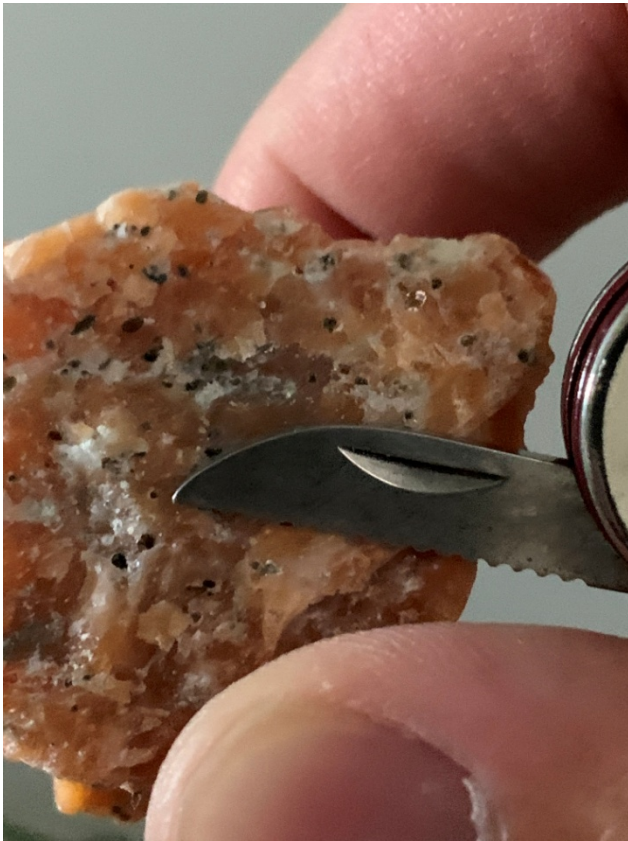
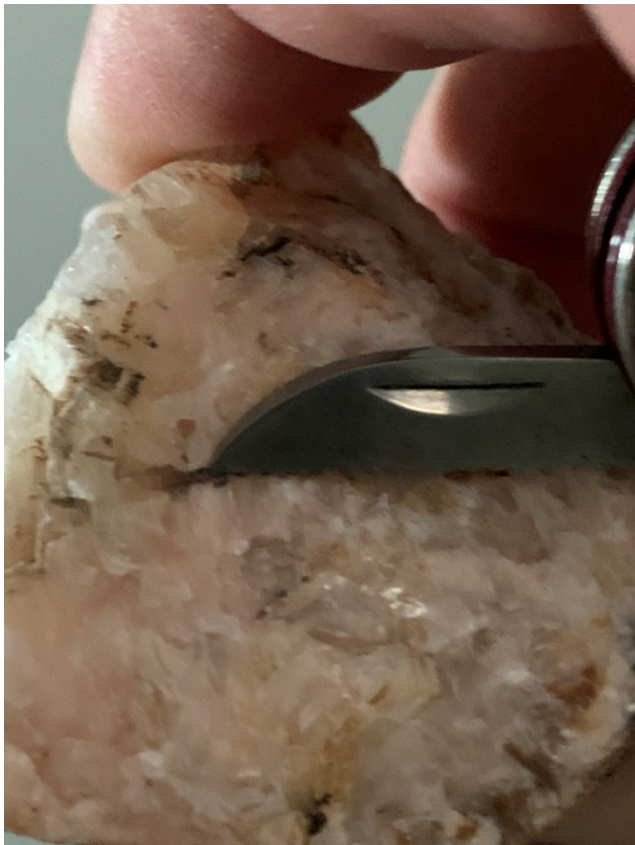
**Fig. 7. Limestone and dolomite are sedimentary rocks that can be scratched with a knife: to differentiate the two, we often need to resort to the use of acids(photo by the author)**

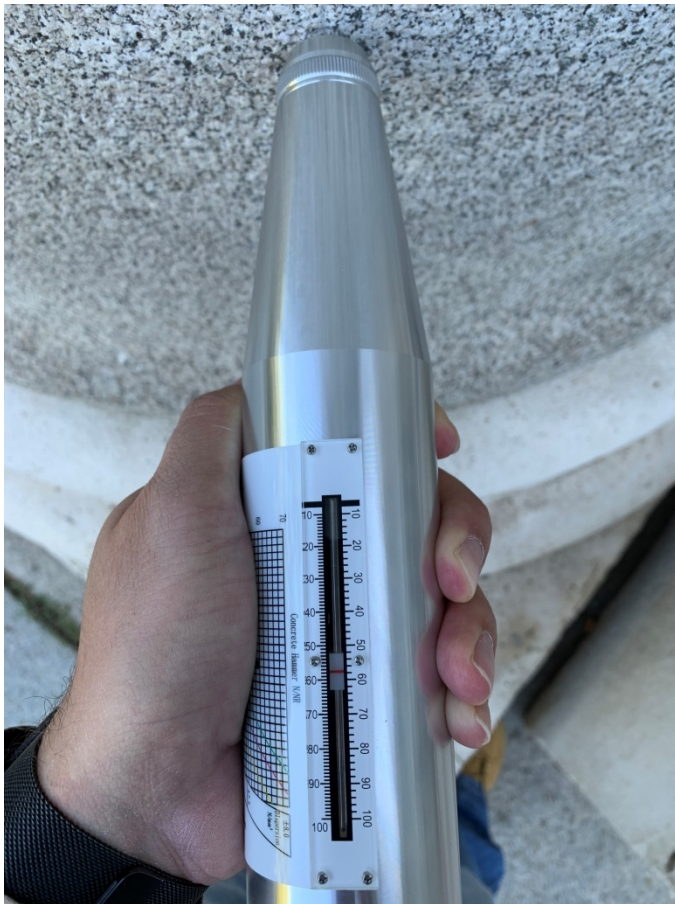
**Fig. 9. Measurement of the mechanical resistance by means of the Schmidt hammer, in a column at the entrance of the Prado Museum in Madrid, Spain (photo by the author)**

**Mechanical resistance determination using Schmidt hammer:** The sclerometer estimates the rebound that the tested material produces in a piston applied with constant energy given by the construction of the instrument. It essentially consists of a plunger, a spring of a certain stiffness, and a piston. The plunger is pressed into the hammer by pushing against the rock surface. The energy is stored in the spring which automatically releases it at a certain level of pressure, impacting the piston against the plunger. The rebound height of the piston is read on a scale (Aydin & Basu, 2005; Aydin, 2008).

There is a relationship between the rebound of the piston and the compressive strength of the material. This relationship is provided by the manufacturer of the Schmidt hammer by means of graphs and tables and has been obtained by comparison with very careful and repeated normalized compression failure tests of cubic and cylindrical specimens that had previously been tested with the Schmidt hammer. If the material is very resistant, the energy received by the impact is returned elastically. If the material is not very resistant, part of the energy received is absorbed in the form of small breaks and deformations (Kong *et al.*, 2021). The presence of cracks close to the impact zone can affect the measurements (Williams & Robinson, 1983; Vandaele & Waelken, 1993). These measurements must be made perpendicular to the surface. The inclination strongly affects the measurements. If it is a question of determining the compressive strength of sound material, a minimum of twenty (20) measurements are required.

The ten (10) that provide lower values are discarded and the average of the ten with higher values is obtained. We assume that the lower ten responds to execution errors, such as the lack of perpendicularity between the hammer and the wall or surface irregularities that disperse the energy of the impact, to name a few. Another utility of this technique is to determine the degree of alteration of the material (Vandaele & Waelken, 1993; San Andrés Moya & Viña Ferrer, 2009; Kröner *et al.*, 2010). If the value provided by healthy material is estimated, lower values would indicate degradation. However, we must take into account the natural heterogeneity of the stone that can provide a dispersion of values within an interval, for samples from the same quarry, without being altered. It is a non-destructive method, so the instrument cost is very useful in heritage where, due to the historical-artistic value of the material, it is often not possible to extract specimens to carry out laboratory tests (Fig. 9). The Schmidt hammer only informs about the superficial characteristics of the material (Buyuksagis & Goktan, 2007), up to where the influence of the impact reaches. This is not usually, however, a drawback: it is precisely the state of the surface and the most important data in terms of conservation. If the information on deeper areas is desired, it is necessary to use more penetrating signals such as ultrasound or, directly, extract cores and carry out tests on them (Kong *et al.*, 2021). The equipment is portable and can be used both in the laboratory and in the field. There are models of the Schmidt hammer for different levels of impact energy. However, the hammer that we use must be suitable for the type of material to be tested. Thus, the impact of the Schmidt hammer will not damage the material, nor will it be so weak that measurements are unreliable (Aydin & Basu, 2005; Aydin, 2008).

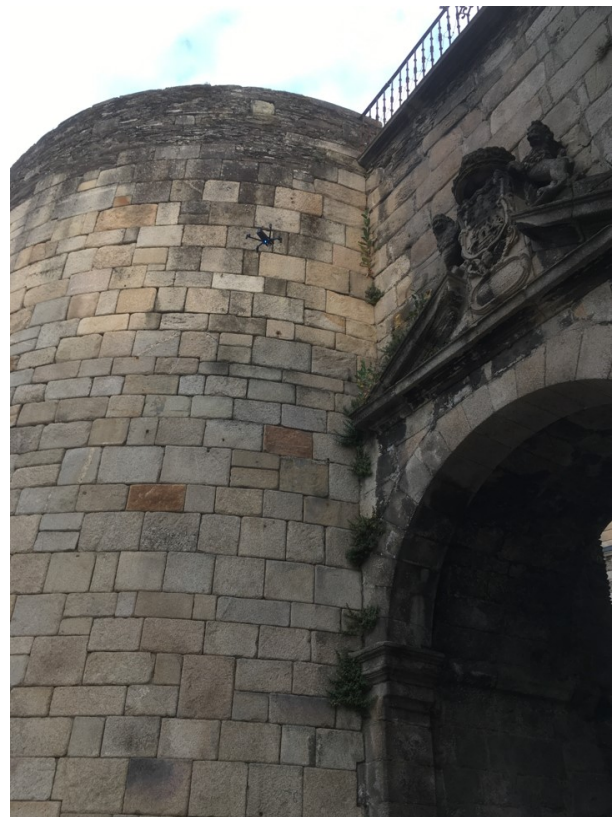
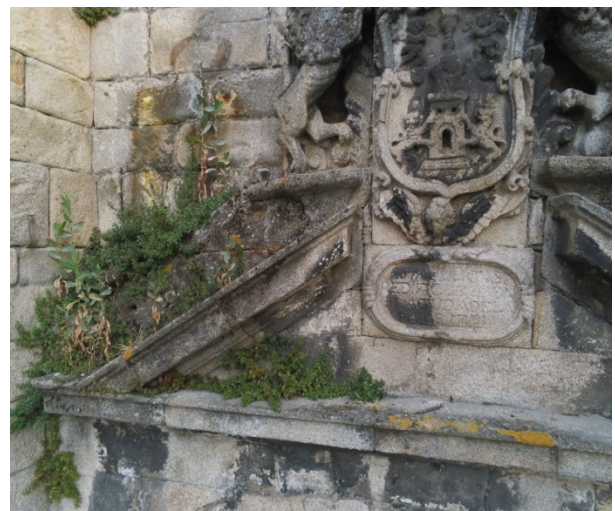
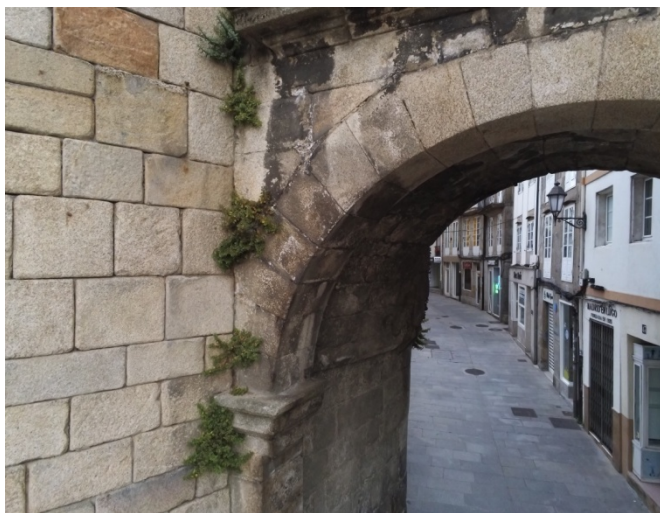
**Fig. 10.** Flight of a quadcopter drone during the inspection of a singular point of the Roman Wall of Lugo; specifically in the Porta de San Pedro ou Toledana (a) and images captured by the drone (c), where the deterioration of the stone material can be observed (photographs by the author).

Un drone During an inspection, a drone (Fig. 10) showed that in its east orientation (outer side of the wall), it received contamination from outside. Because of this, black scabs appeared. Loss of relief and sandstone, in synergy with biological growth (Fig. 10, a and b). Vehicles cannot circulate inside the wall (only in exceptional cases) for years. For this reason, the granite appeared clean on the west face (interior side of the wall). The climatic historical record can be obtained from the nearest weather station. However, many times we are interested in knowing the microclimate in the monument or even in parts or orientations of it (Guerra *et al.*, 2019). For rapid data collection, there are pocket instruments that allow us to estimate the prevailing conditions at a given time.

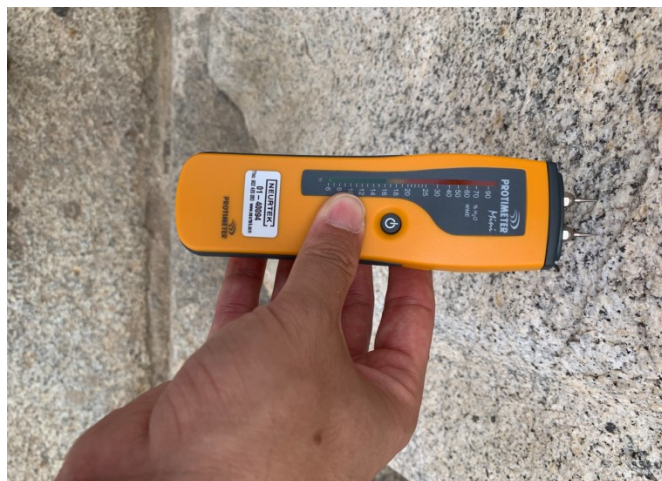
**Fig. 11.** Humidity measurement using a protimeter in ashlar of the facade of the Monastery of El Escorial, Spain (photograph by the author)

**Moisture and salt mapping:** We have already commented that many pathologies have their origin in the presence of humidity, which is accompanied by salts (Liu *et al.*, 2020). The damaging effect of humidity on monuments is also well known (Kröner *et al.*, 2010; Tortajada Hernando, 2011; Lovón&Lovón, 2019). Humidity mapping is usually carried out with the aim of knowing its origin from its distribution. Sometimes, the presence of moisture is evident to us from stains or visible modifications of the surface. The humid zone traps dust and dirt from the environment and gives rise to fungal biocolonies that produce changes in tone or color (Caneva *et al.*, 2000; Valgañón, 2008). Other times, areas that were wet have dried, but the stains remain. Other times, for different reasons, the presence of humidity is not evident from observation alone. It can also happen that humidity is transmitted mainly through the joints, while the stone is quite dry. In this case, they are difficult to appreciate visually. Humidity mapping is carried out with a protimeter (Fig. 11). A protimeter is essentially a moisture measurement probe on surfaces. It makes point estimates of the electrical conductivity of the material. Distilled water hardly conducts electricity. However, in construction, moisture carries electrolytes due to dissolved salts. These electrolytes make this water quite conductive. The determination of the humidity at each point is quite fast. Thus, we can take many points in a short time. These points can be established according to a regular grid, but it can be difficult in situ, due to access difficulties (Fig. 14, left). When the element is linear, such as a column, cartography can be converted into a linear profile (Fig. 13, color blue). To carry out the mapping of salts, previously there was equipment on the market for the measurement of salts. However, some of this equipment has been discontinued, so it is less accessible. It forced many professionals to look for alternative solutions. Thus, Professor José María García de Miguel designed and built a piece of equipment based on electrical conductivity also (García de Miguel, 2009). In this equipment (Fig. 12) we do the measurement in a different way: we use filter paper, moistened with distilled water on the surface where we want to measure the saline content.

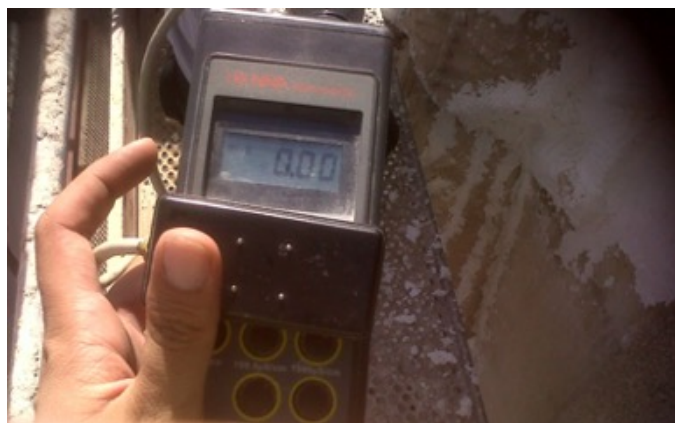
**Fig. 12.** Equipment used for the measurement of conductivity and, therefore, for the measurement of salts in the Patio de Santo Tomás of the University of Alcalá de Henares, in Spain (photo by author).

Thus, the paper transmits moisture to the material. After a few seconds, the salts that lodge in the pores of the material dissolve in the moisture that impregnates the paper. So, we place the paper between some electrodes and measure the conductivity. This measured conductivity will be proportional to the saline content in the water dissolved in the paper and, ultimately, to the salts that have been extracted from the wall. Naturally, in the case of very poorly soluble salts, such as calcium sulfate, a much higher content will be needed than in the case of sodium chloride, to provide the same conductivity value, and it can be objected that the measurement does not really estimate the content. saline since it depends on its nature. his objection is real, but not very relevant to the intended practical effects. In fact, what is estimated is the capacity of the salt attack to produce damage, which is, ultimately, what is of interest. A low content of sodium chloride can be so harmful that a very high content of calcium sulfate will produce the same electrical conductivity (Alves *et al.*, 2021). However, if we know the nature of the salts estimated by other methods that we will see in the next section and this salt composition is constant (for example, if there is only sodium chloride), we could prepare calibration curves with different concentrations of salts. and the response of the instrument at each concentration.

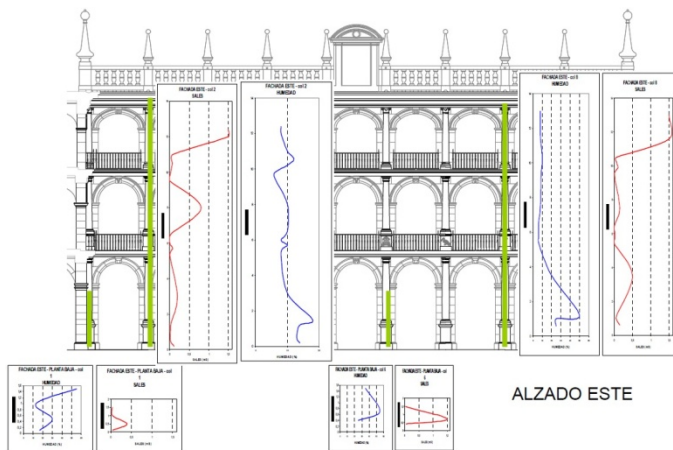
**Fig. 13. Moisture profiles (blue) and salt concentration profiles (red) in the plane of the east side facade in the Patio de Santo Tomás, at University of Alcalá de Henares, Spain (Elizalde, 2012)**

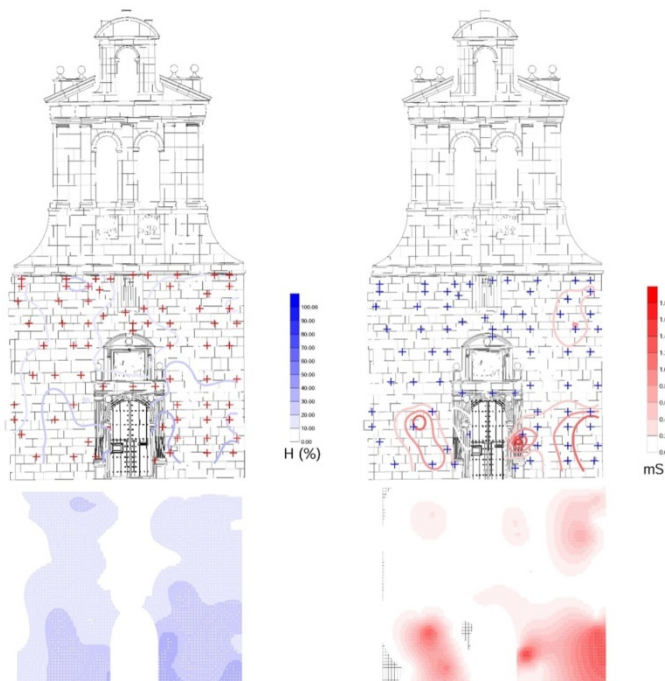
**Fig. 14. Humidity cartography (left) and salt concentration cartography (right) in the elevation of the main facade of the Chapel of San Ildefonso, in Alcalá de Henares, Spain (Elizalde, 2012)**

Guerra *et al.*, 2019), or in brick (Lourenço, 2014). If we mix the data collections in different materials, the cartography can be distorted, because the values obtained depend on the porosity of these materials and the nature of these materials. Normally, the most sensitive and most convenient material is the most porous material (Charola, 2000). However, highly absorbent materials can dry out the paper by immediately drawing out the moisture it contains. Once dry, this material will give us conductivity values much lower than the real ones, or it will not give us any value at all. In this case, we must choose the least porous material. For this reason, it is best to carry out two parallel cartographies: one in joints and another in the center of the pieces. Comparing both, we can see in most cases that the measurement carried out on the pieces reflects that of the joints, attenuated. The one that is estimated in the pieces better discriminates the main sources of humidity and salts, while one of the joints is, generally, more sensitive in detecting the distribution of humidity, where this is not revealed in the pieces. The salt maps (Fig. 14, right) indicate the areas to be intervened by salt extraction, excluding the areas that do not present content. As mapping is much less expensive than extraction, you can save unnecessary costs by excluding many areas in the intervention. The maps of salts and humidity can be superimposed. This superposition provides us with information about the presence of fossil salt fronts or active salt fronts. An occasional event such as, for example, the breakage of a sewage pipe, can be the cause of salts remaining after solving the cause that contributed the humidity, generating a fossil front. The presence of moisture without salts are usually rare. These spots indicate areas of high circulation and little evaporation, so that the salts are transported, but not deposited and accumulated. In the fronts by capillarity, the low zones with a lot of permanent humidity usually present low saline values that increase in the evaporation zone at higher elevations.

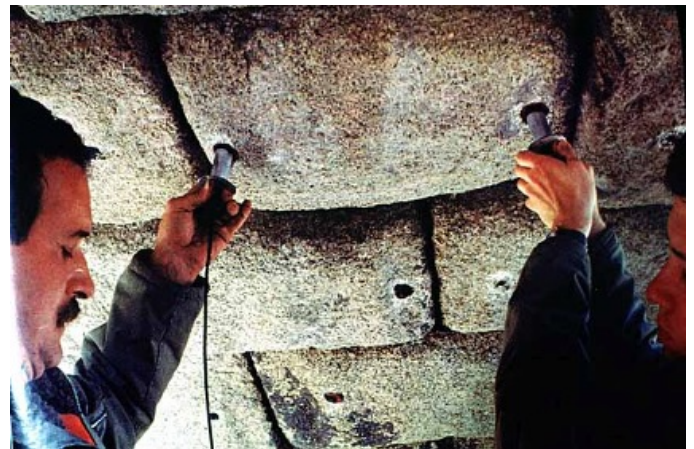
**Fig. 15. Auscultation of the ultrasonic transmission speed in the ashlars of the Roman Aqueduct of Segovia (Jurado, 2007)**

Ultrasounds were developed to examine metals and welds and from there they went to medicine. Later they have begun to be used in construction. This technique consists of an emitter of ultrasonic frequency longitudinal vibrations, which pass through the material, and are received by a receiver. The speed of propagation of the ultrasonic wave through the material is measured. This speed is directly related to the elastic modulus of the material and, therefore, to its mechanical properties (Diana & Fais, 2011; Jo & Lee, 2022). This speed is estimated

by the space between the emitter and the receiver and the time it takes for the emitted signal to be acknowledged by the latter. This technique requires good contact between the transducers (emitter and receiver) and the surface. For this, it is recommended to use petroleum jelly, grease, liquid soap or kaolin paste, and glycerol. The roughness of the surface is a drawback, so it may be necessary to polish it or use quick-setting epoxy resin. There is a UNE standard (UNE-EN 14579:2005. Natural stone test methods - Determination of sound speed propagation), which specifies the method to carry out the test, both in the laboratory and in situ. The estimation can be done by reflection, but it is usually done by transmission. The best situation occurs when you have two facing surfaces, such as a wall accessible from both sides. When estimation is not possible in this way, it is possible to place the emitter and receiver on the same surface (Fig. 15). Ultrasounds are used to measure the homogeneity of concrete and other identical materials (such as stone materials, which are the ones we are interested in). It has also been used to estimate the depth and direction of fractures within the material (Diana & Fais, 2011). However, resistance estimation is strongly influenced by the distance between transducers, surface roughness, or humidity (Jo & Lee, 2022). Therefore, we should only apply this technique over dry materials.

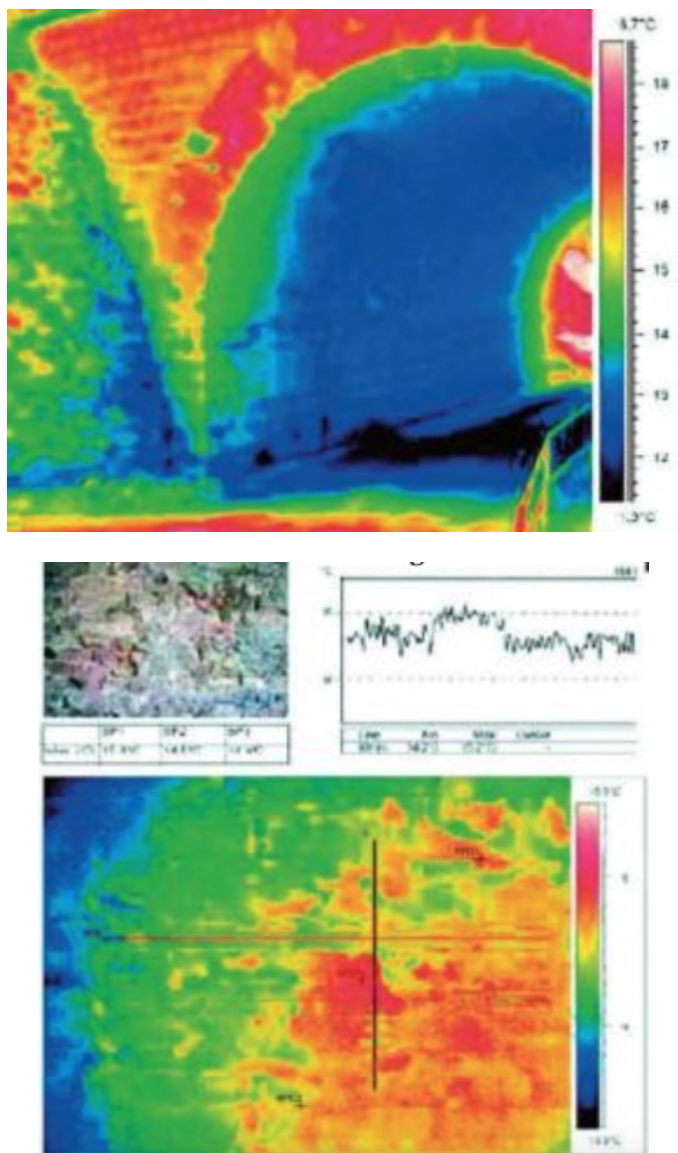
Fig. 16. Thermography of a masonry bridge (Urzaiz, 2017)

Infrared rays have a lower frequency than visible light. For this reason, the human eye cannot detect them. However, these rays can be perceived organoleptically as heat. Thus, the camera records the temperature of the different objects in an image (Fig. 16). Depending on the camera, it can become sensitive to hundredths of a degree. Thermography is another technique that we can also use to detect possible defects in masonry. Infrared thermography allows, through the infrared radiation emitted by bodies, the surface temperature measurement (Pappalardo *et al.*, 2022). The instrument used in thermography to measure is the infrared camera. The main advantage of thermographic temperature measurement is that it is a non-contact measurement technique (Diana & Fais, 2011). In recent years, new thermal imaging cameras have greatly decreased in price and can help us to appreciate cracks and anomalies. The campaigns must be carried out at dusk or dawn because what the cameras detect is the different temperature

that manifests itself in the walls of the bridge and it is at these times when it is easier to observe the possible presence of non-homogeneous areas that will dissipate the heat of differently (Carlomagno *et al.*, 2005).
