CONDITIONS OF HYDRAULIC STRUCTURES IN THE BIRNI N'KONNI REGION (NIGER) DURING LOW-WATER PERIODS AND THEIR POSSIBLE IMPROVEMENTS

The Birni N'Konni hydro-agricultural structures are hydraulic works utilized for agricultural purposes in this region of Niger. They play a pivotal role in the country's economy. In recent years, these hydraulic infrastructures have been subjected to a multitude of degradation factors, both physical and chemical in nature. The physical factors include erosion, sedimentation, and fatigue, while the chemical factors encompass corrosion and pollution. Additionally, biological factors, particularly the impact of vegetation, have also contributed to the deterioration of these structures. Anthropogenic factors, such as overuse, inadequate maintenance, and design flaws, have also played a role in the observed degradation. For this reason, the primary objective of this study is to conduct a diagnostic analysis of the Konni hydraulic structures with the aim of proposing strategies for enhancing their performance and mitigating their deterioration, particularly during periods of low water levels. The approach adopted is that the integration of computational and des

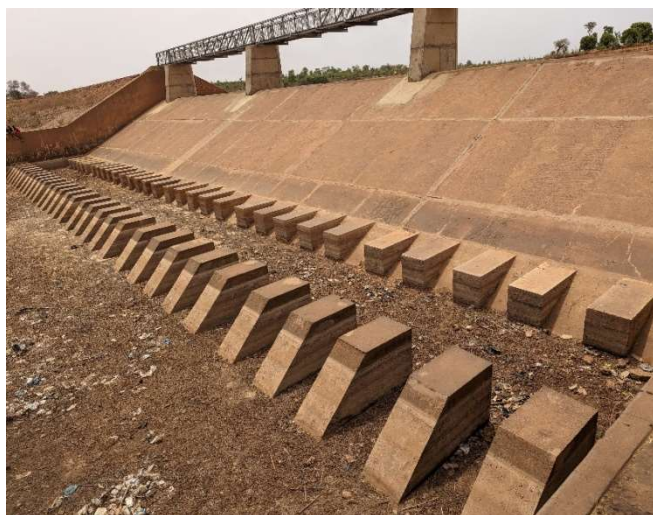
Figure 3. Zongo Dam during low water period

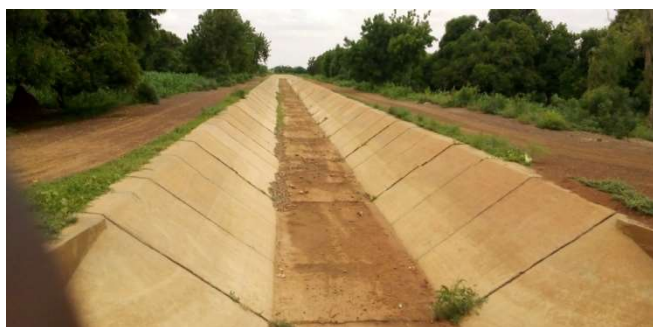
Figure 4. Primary canal silted up and covered in grass during low water periods

Furthermore, it is important to note that most of the canals are not in good condition; they are in a state of almost total disrepair, and their efficiency is almost non-existent. This prevents water from reaching its intended destination. When it comes to construction, a poorly executed structure means a loss of money from the moment it is built, and a further loss in terms of maintenance. It's vital that structures are designed and built with the utmost rigor and attention to detail, to

Enhanced maintenance and rehabilitation of hydro-agricultural facilities by operators and the Nigerien government: This part of the proposed solutions is particularly important, as regular, well-maintained structures require very little costly rehabilitation, and operators should regularly weed the canals, clean the tracks and other ancillary structures, and clear the undergrowth from the dams. On the other hand, it's incumbent on the Niger government to perform large-scale maintenance work with the participation of its financial and technical partners, providing them with the necessary machinery and other resources. It would be important to make use of any new technology aimed at improving the performance of these structures.

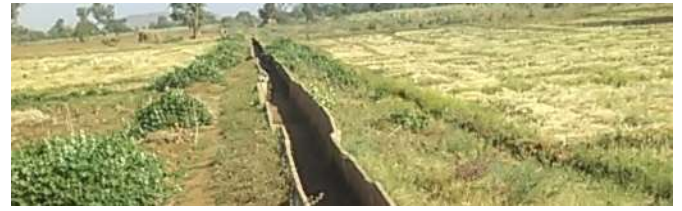
Figure 5. Tertiary canal degradation

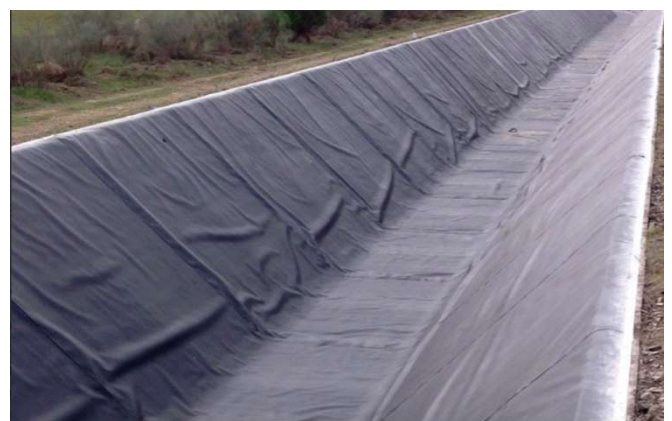
Figure 6. Laying a geomembrane along a canal in Spain [23]

Figure 6 illustrates how the geomembrane protects the pipe walls against erosion, thereby ensuring the longevity of the structure. This would be ideal for rehabilitating the canals of the Konni hydro-agricultural scheme. As for geotextiles, these are non-woven or woven textiles designed to be permeable to water while offering tensile strength. They can be used as separators, filters and reinforcements. They are used to reinforce structures by preventing them from falling or collapsing, and at the same time to avoid erosion that could result from such collapses.

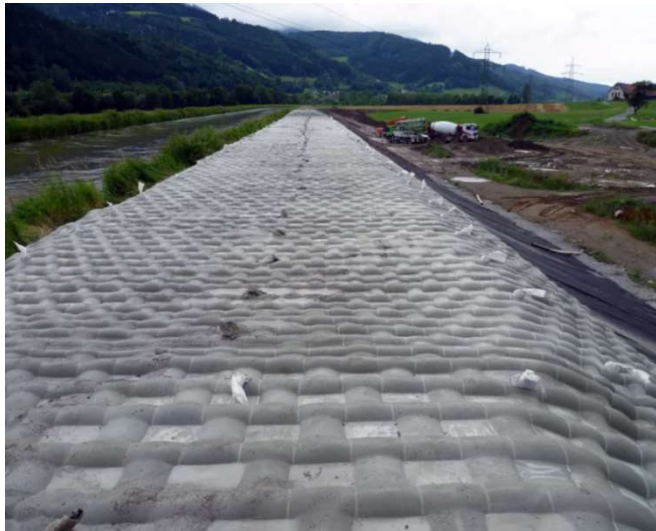
Figure 7. A dike strengthened with geotextiles [24]

The formation of revetments of soil, rockfill or concrete can control the erosion of exposed surfaces. Geosynthetics make it possible to combine these materials, based on their high strength and durability, to create durable, versatile and cost-effective structures, such as geotextile-reinforced embankments. Geosynthetics can also be used to protect the walls of structures against perforation and wear. This technology could also be applied to the protection dike and dam dikes of the Konni hydraulic works.
